FERNWOOD LAKE EAST DAM
MA 01336

FERNWOOD LAKE WEST DAM
MA 01337

PHASE I INSPECTION REPORT
NATIONAL DAM INSPECTION PROGRAM

SEPTEMBER, 1980

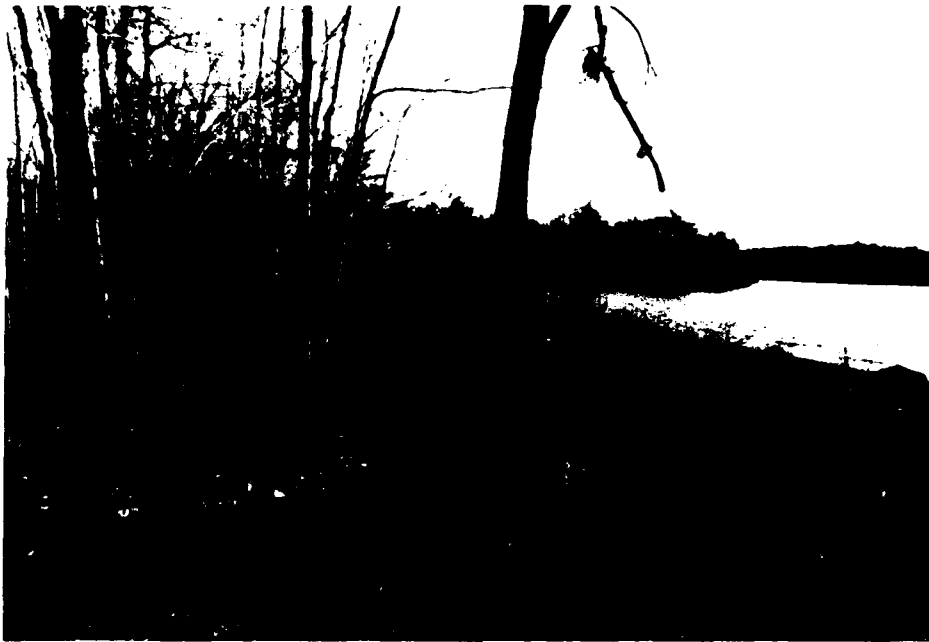
19. Trees and roots on downstream side near left abutment (2 May 1980)

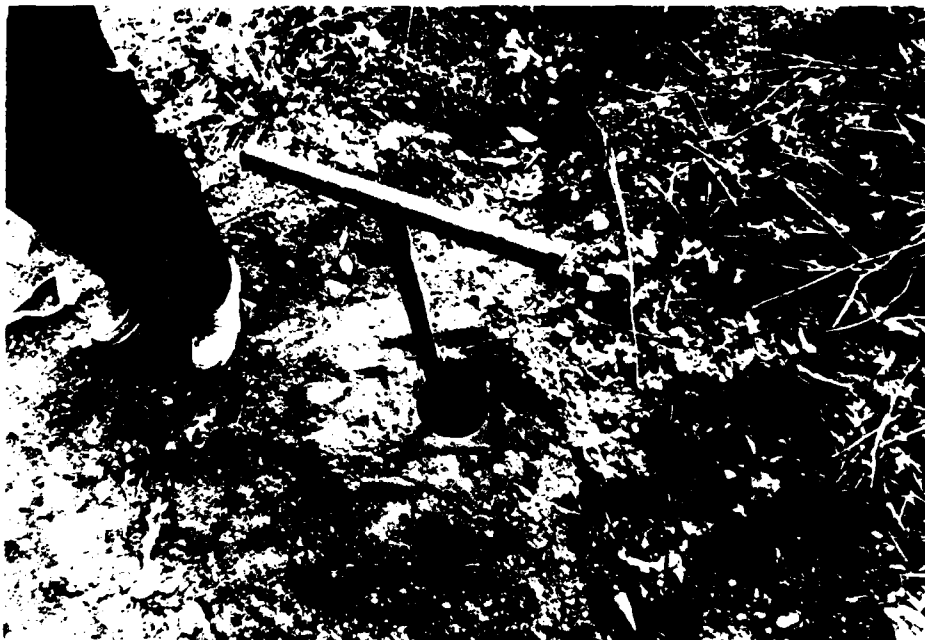
20. Handle for operating outlet gate valve inserted through opening in buried manhole cover (2 May 1980)

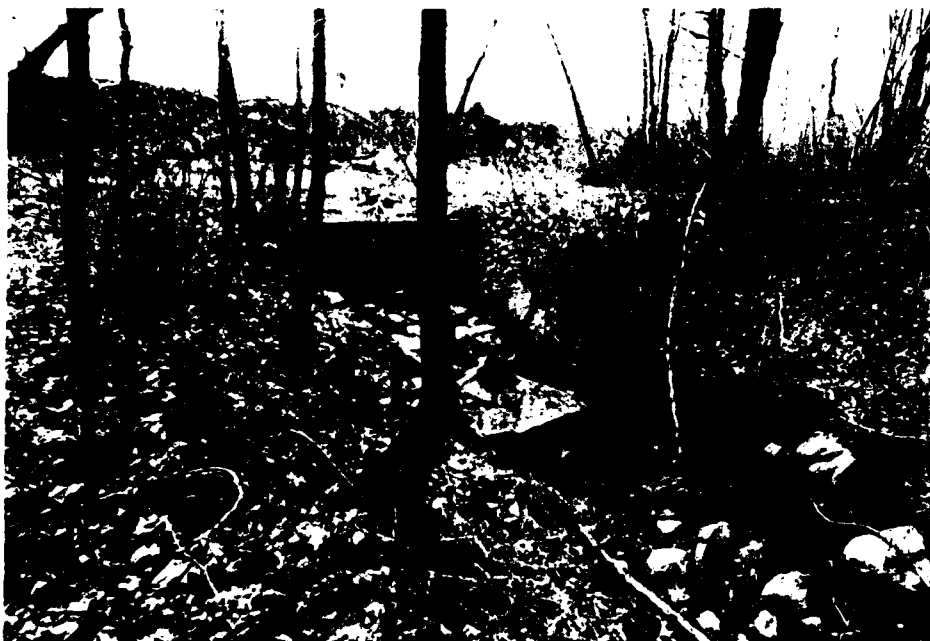
21. Outlet structure and channel downstream of
West Dam (2 May 1980)
